A Review of Current Knowledge

**CAUSES OF COPPER
CORROSION IN
PLUMBING SYSTEMS**

FR/R0007

February 2003

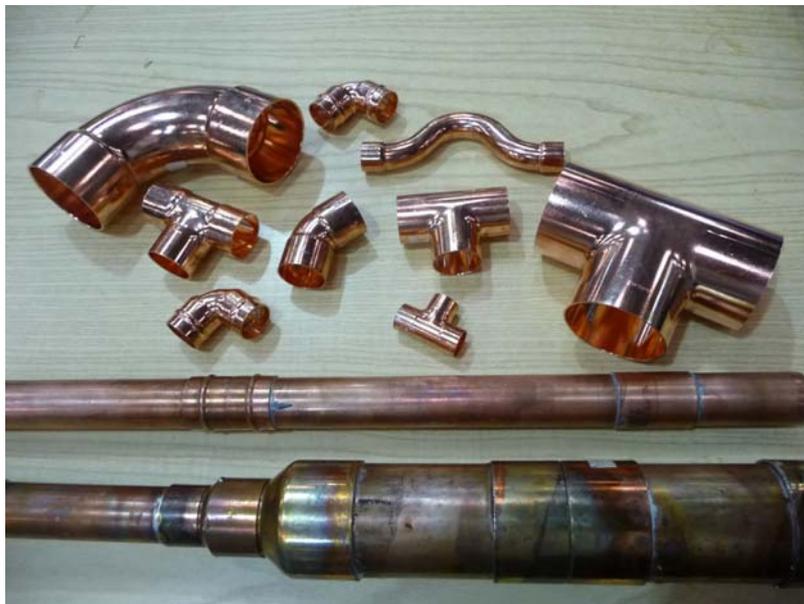
Capillary (soldered) fittings are formed from copper tubes or copper alloys by pressing or stamping, see Photograph 1. Once the pipe is inserted into the fitting, the whole joint is heated and solder runs into the narrow space between the pipe and the fitting. The solder can either be end-fed into the joint using solder wire or included in the fitting during manufacture.

Photograph 1. A selection of capillary (soldered) fittings

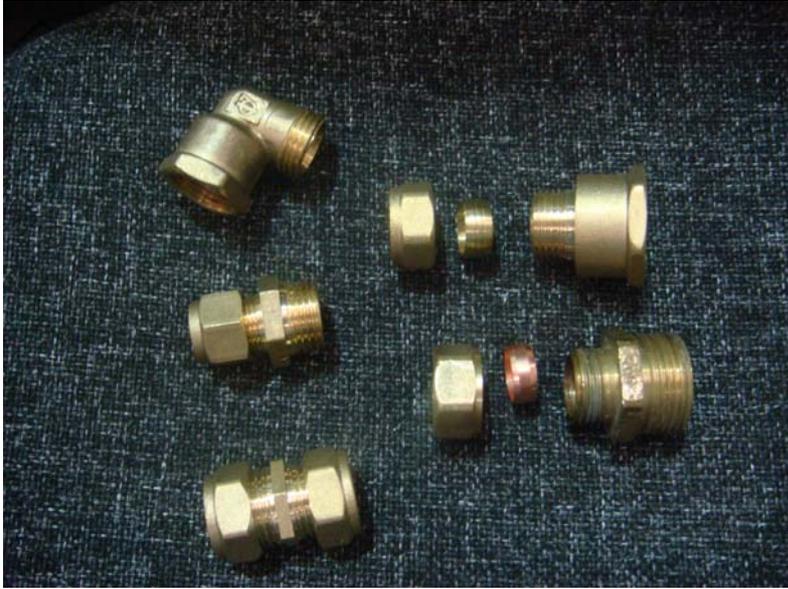
Compression fittings are stamped or sand-cast from copper alloys, see Photograph 2. Once the pipe is inserted into the body of the fitting, the nut is tightened onto the body. Compression fittings normally incorporate metal sealing rings (called olives) that grip onto the outside wall of the pipe when the retaining nut is tightened. Two different olives can be seen on the right hand side in Photograph 2 where one is copper coloured and one is brass coloured.

Photograph 2. A selection of compression fittings

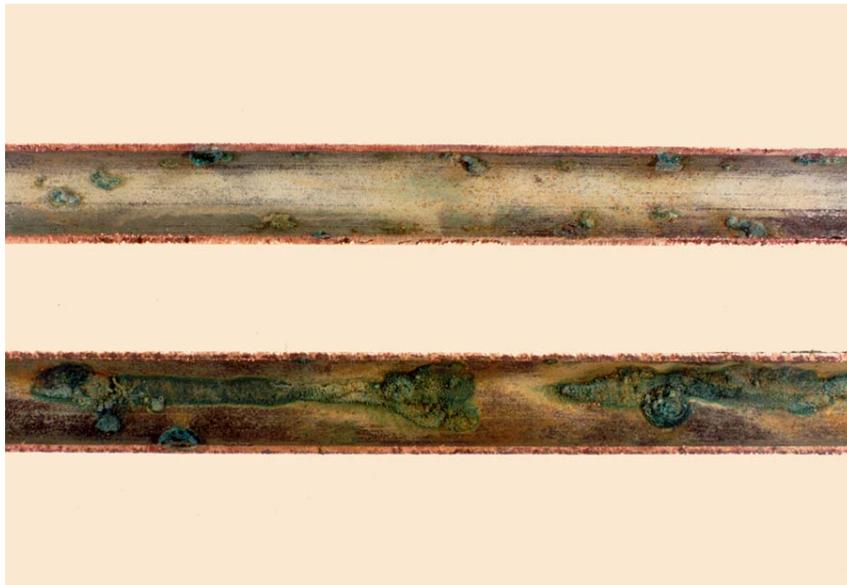
What to look for: Typically the pipe or cylinder fails after three to four years of service but sometimes within a few months. When a failed section of pipe is removed and sectioned longitudinally, corrosion deposits can be seen that are deep-green usually well-spaced mounds above the pits or pinholes in the pipe wall, see Photographs 3 and 4. Smaller inactive pits may be seen between the active pits.

Cause: The type of corrosion requires a continuous carbon film in the bore of the pipes and a specific water quality. In pipes, the presence of a carbon film produced in the manufacturing of pipes (References 5 and 6) can provide the driving force for the propagation of a pit. The water has to be hard, organically pure and is typically from a borehole. Type I pitting does not normally occur in surface sources as this water contains natural organic material that inhibits corrosion (Reference 7). For further information, see Section 3.

Photograph 3. Typical distribution of Type I pits in copper pipe

What to do about it: The conditions which lead to Type 1 can be avoided by using products which meet BS EN 1057. It is normal practice for manufacturers to take measures to remove, or prevent the development of, deleterious carbon films. Tubes conforming to BS EN 1057 should not be susceptible carbon film cold water pitting as the standard specifies a carbon content and carbon film test.

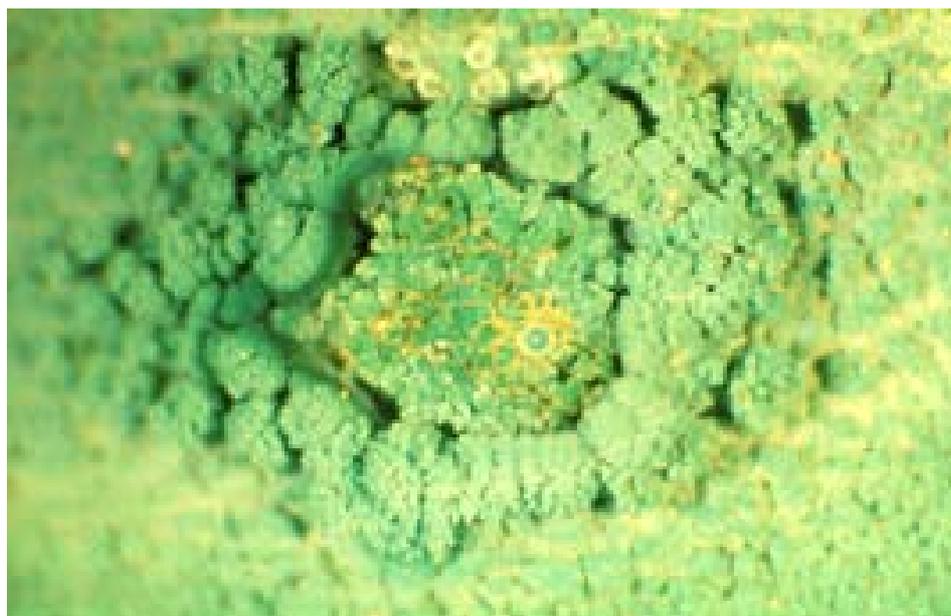
Photograph 4. Detail of a Type I pit with a central mound of malachite above the initiating site surrounded by secondary mounds above daughter pits

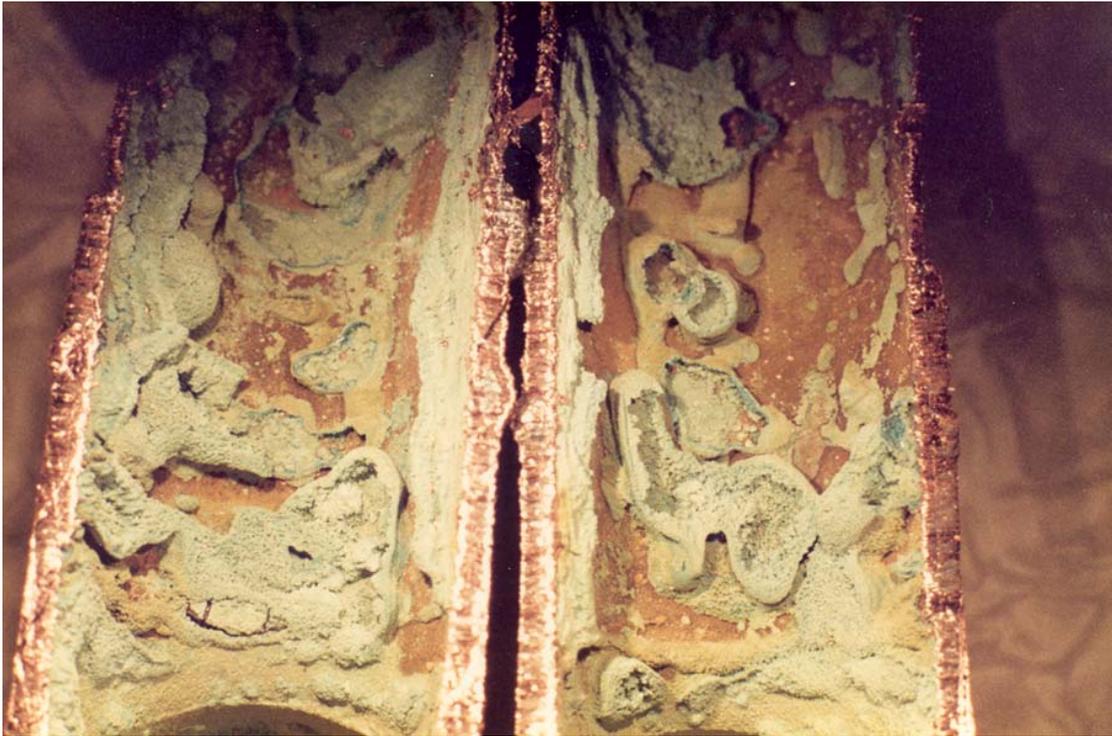
It should be noted that the phenomenon of voluminous corrosion products developing in pipes after prolonged contact with soft waters is seen with some UK water supplies, see Photograph 5. However, these structures are not usually associated with pitting.

Photograph 5. Voluminous corrosion deposits produced by soft water

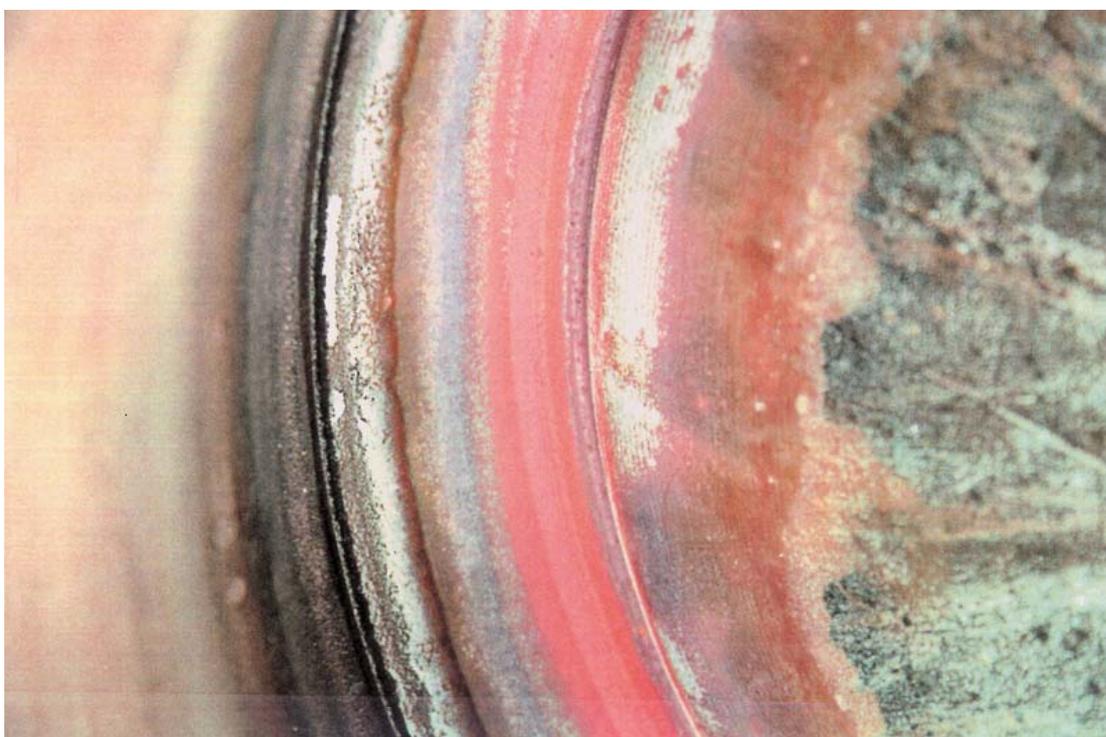
What to look for: Typically the cylinder will fail due to thinning of the cylinder wall, leading to perforation, after prolonged use. When the cylinder is opened up, heavy sediments can be seen of an aluminium corrosion product that varies from white with a bluish tinge to light green in colour (Photograph 6). Underneath these deposits, the copper is a vivid brick red magenta colour consisting of large platelets of copper(I) oxide separated by deep trenches; hence the original name ‘Rosette pitting’. However, it is probably more accurately described as a general attack due to the development of highly corrosive conditions beneath the aluminium corrosion deposits.

Cause: Research (Reference 9) into the causes of this problem established that the aluminium/copper galvanic couple was so energetic that it reduced the nitrate in the water to ammonia and some of the sulphate to sulphide. Both of these ions are highly corrosive to copper. It was clear from the composition of the waters in which Rosette corrosion was occurring that there was not an absolute level of

Photograph 6. View of the internal surface of the base of a hot water cylinder (after the removal of all loose deposits) showing the broad intensely red corrosion product layer in the peripheral crevice where Rosette corrosion has become initiated

What to do about it: The problem of Rosette corrosion has been solved by a re-design of the hot water cylinder so that an aluminium protector rod is no longer required. The re-design has involved lowering the position of the heating coil so that the base of the cylinder operates above 40° C where a semi-protective corrosion layer is formed.

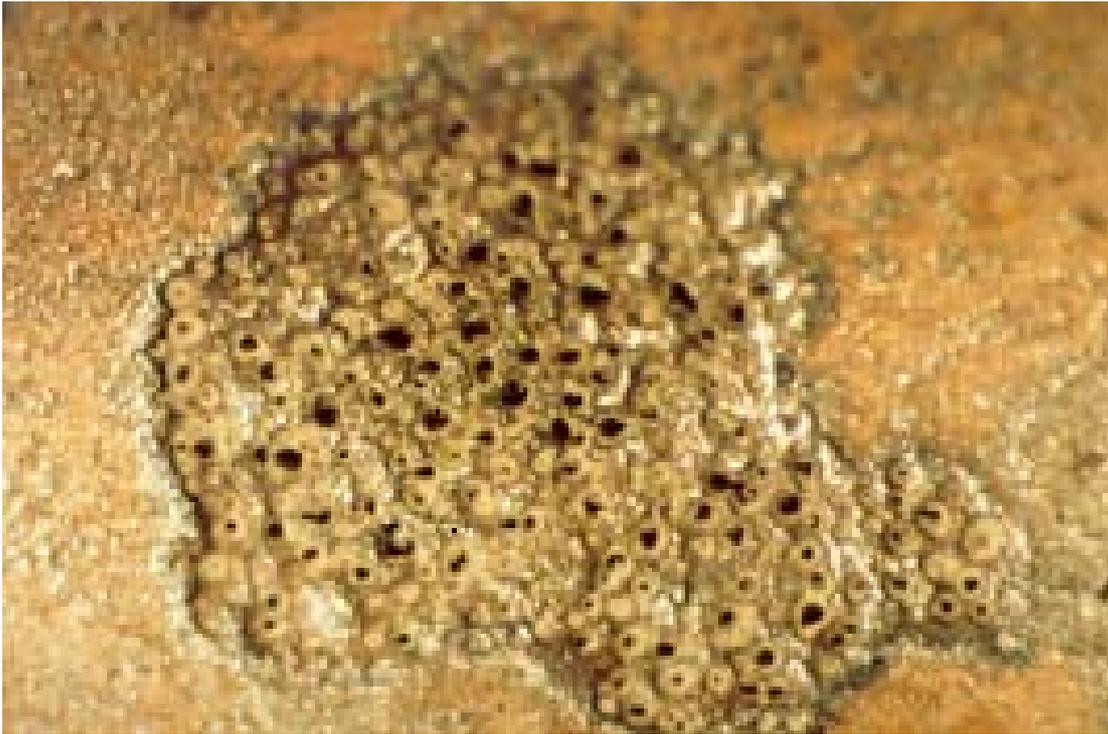
What to look for: (i) Leakage in the pipework occurs as a result of the thinning of the wall leading to pitting/ pinholes. When the section of pipe is removed and sectioned longitudinally, copper tubercles can be seen, often above multiple initiation sites, overlaid with a black precipitate ('pepper pot corrosion', Photograph 7). (ii) General corrosion also leads to the sporadic release of copper into the water, which could lead to a slight metallic taste to, or discolouration of, the water.

Photograph 7. An acid cleaned copper pipe surface showing ‘pepper pot corrosion’ produced by microbiological action

- Address system problems: ensure hot water is maintained hot and cold water kept cool.
- Clean out the corrosion deposits with a citric acid solution containing surfactants.
- Flush with hot water (>60°C) where a cold water system is affected.
- Add carbonate hardness using carbon dioxide and a filter of marble chips.

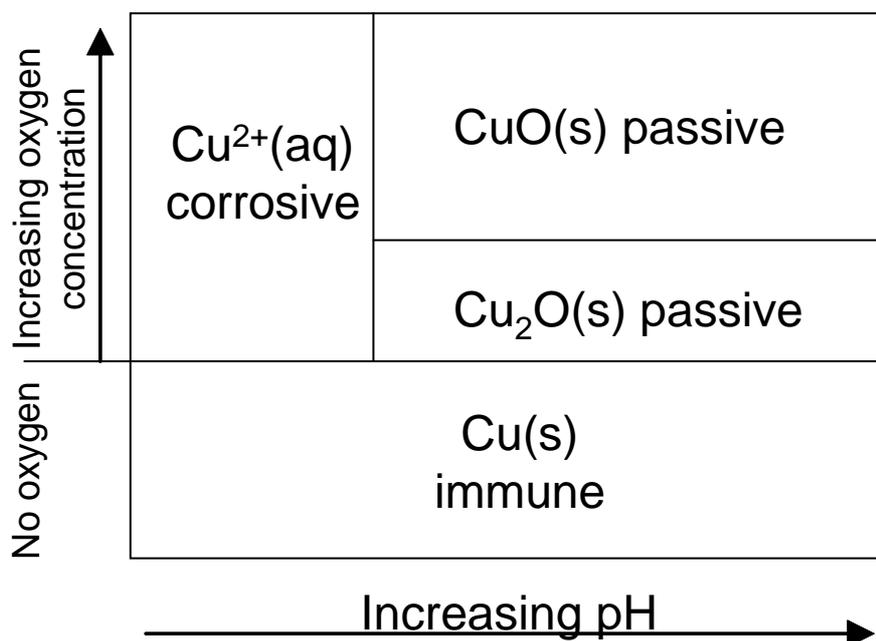
Copper's resistance to corrosion relies upon a small amount of corrosion at the pipe surface to form a protective (semi-passive) layer that stifles further corrosion. Whether a significant amount of corrosion occurs, and the type of corrosion product that is formed, will depend upon the conditions to which the pipe is subjected. For cold water these can be categorised into four general conditions that are summarised in Figure 1 and described below.

1. In waters with a low oxygen content (anaerobic conditions, e.g. a stagnant water) the metal itself is stable, that is, it will not corrode readily.
2. In acidic waters ($\text{pH} < 6$) with oxygen present (aerobic conditions, e.g. in a moving water), the metal will dissolve to form the Cu^{2+} ion that is the most stable form in these conditions. Such waters are termed *cuprosolvent* and the condition is discussed in the main text.

3. In neutral to alkaline waters (pH 6-8) with a reasonably high oxygen content (>2 mg O_2/l , aerobic conditions e.g. in a moving water), the metal will initially produce an insoluble layer of copper(I) oxide or cuprite (Cu_2O). This magenta red to brown corrosion product will be the most stable species in these conditions and will form a semi-protective scale against further corrosion.
4. In alkaline waters (pH >8) with a high oxygen content, copper will form a layer of copper(II) oxide, or tenorite (CuO). This jet black to brown corrosion product will be the most stable species in these conditions and will form a protective scale against further corrosion.

Figure 1. Copper corrosion products as a function of pH and oxygen concentration. (aq) = dissolved, (s) = solid.

Layering of the solid corrosion products, much like the solids in Figure 1, can be seen inside pipes where Cu_2O forms closest to the copper metal surface (where the oxygen concentration is lower) and CuO forms a layer on top of the Cu_2O and in contact with the water (where the oxygen concentration is highest).

Of these four species in Figure 1, only the Cu^{2+} ion is significantly soluble. The films that form on copper are only semi-protective and corrosion continues, albeit at a much reduced rate to that of the initial bare metal rate. The semi-protective scales that initially form in case 3 and 4 often develop further insoluble layers, e.g.
